# Rehabilitation of Mechanics Hall

Matthew J. Cogswell  
*Worcester Polytechnic Institute*

Mechanics Hall is an historic building built in 1852 in Princeton, Massachusetts. The project goal was to develop a plan to bring Mechanics Hall into compliance with current building code requirements. A field inspection was performed to gather data used to develop a Building Information Model. Due to the extensive use of building code, a Code Review was developed, along with a design and cost estimate for two proposed uses. The results were presented to the Friends of Mechanics Hall.

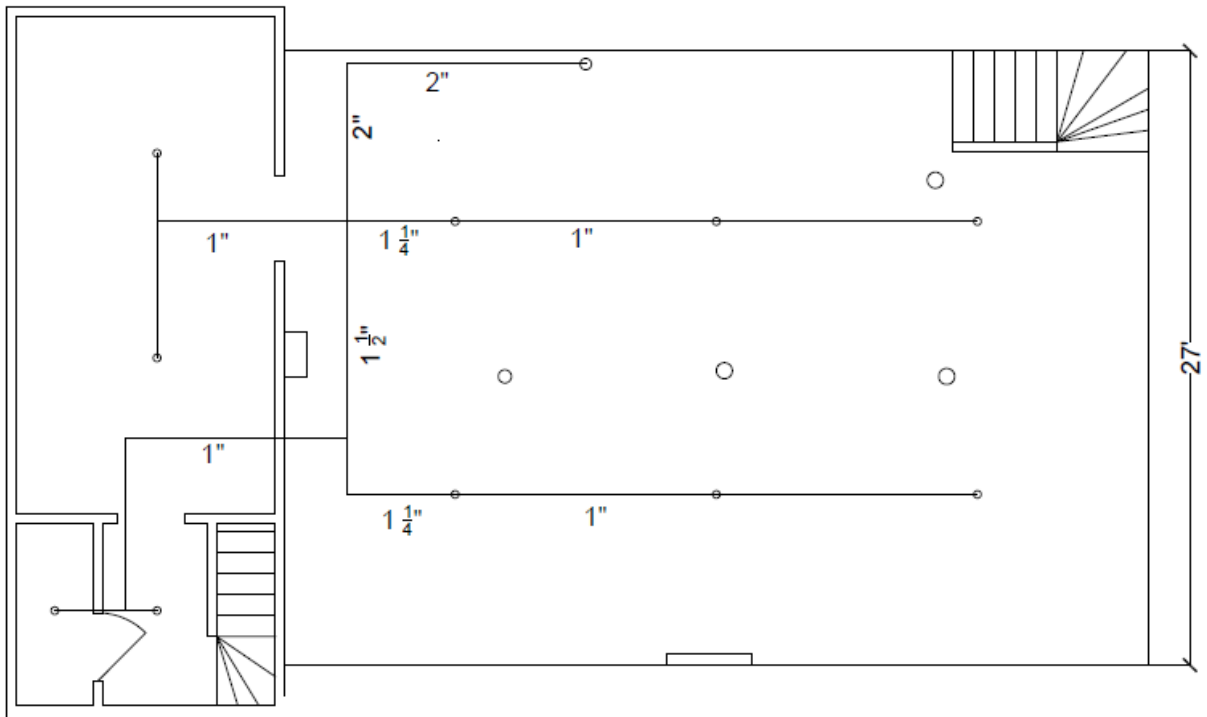
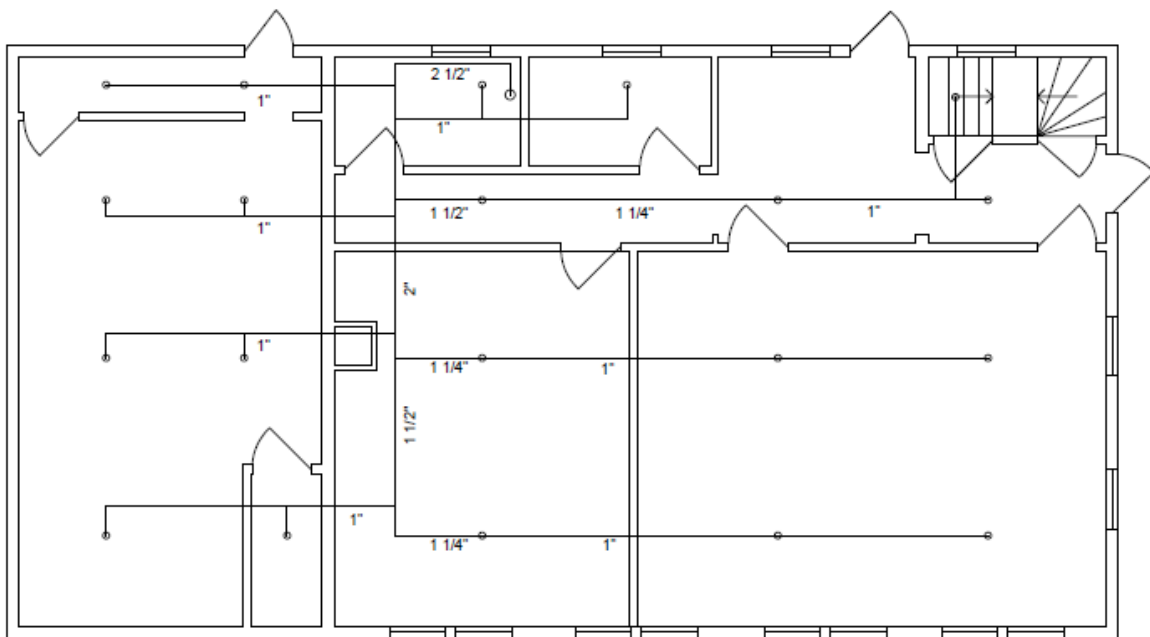
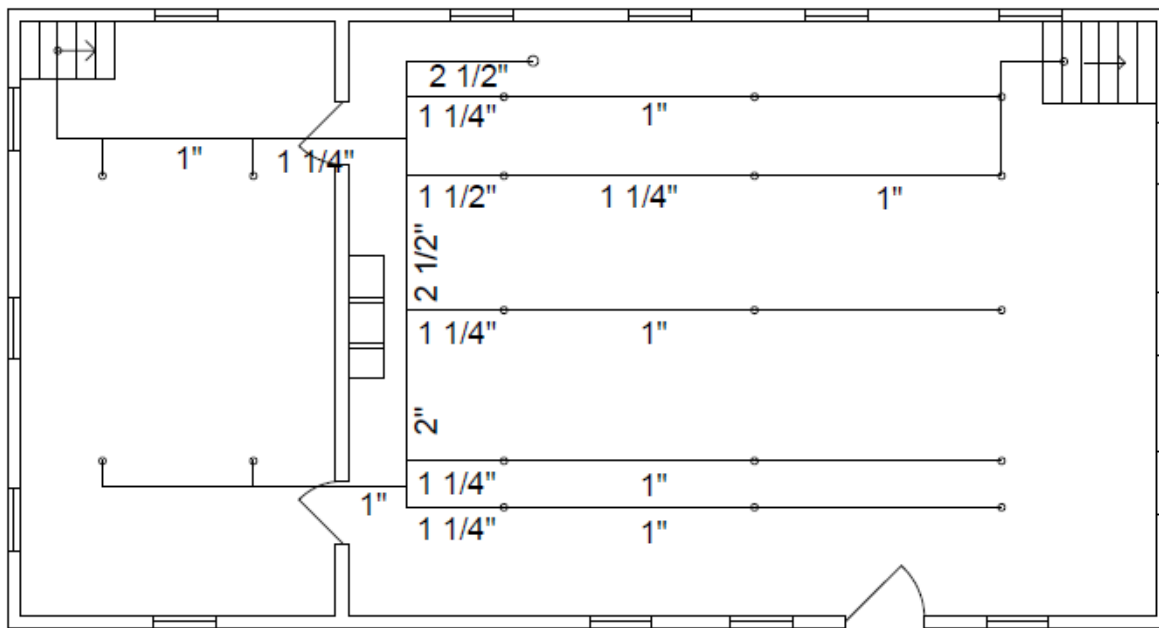
When designing the system some further issues arose. Because there is no heat in this building the installation would have to wait until a heating system was installed. The presented drawings in Figure 26-28 do not consider the impact of the ductwork. Another issue is the observation that the attic will probably not be warm enough to permit the use of a wet pipe sprinkler system due to risk of freezing. Because of this dry uprights need to be used. These dry uprights would have to be supplied from the second floor where temperature would not be an issue. Very simply, a dry upright is a piece of pipe with a sprinkler head attached to it that does not have any water in it. When the head is activated water flows through the pipe and out of the head. NFPA 13 states that sprinkler heads must be a minimum distance of 3 feet away from a sloped roofs peak. Because of this a large enough dry upright needs to be used to get within 3 feet of the roof of the building.

After determining the sprinkler head spacing requirements the CAD files were created as seen in Figure 26-28. According to NFPA 13 Table 8.6.2.2.1(a) the maximum area between heads is 225 square feet, and the maximum spacing is 15 ft. This design could be changed depending on where the water enters the building from the water tank. It was assumed the water came in from the larger circle on the right of the building.

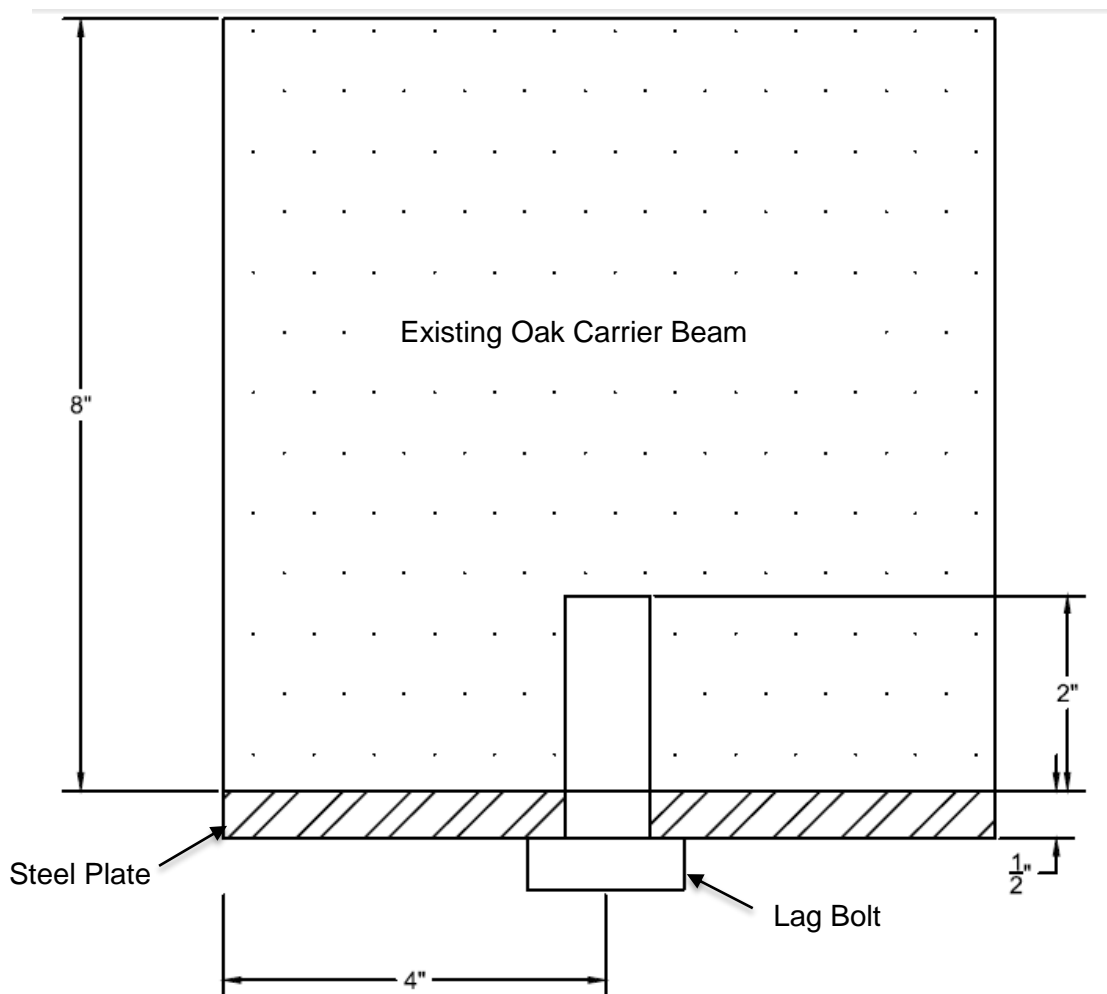
Figure 29: Composite Beam Section View

The carrier beams were determined to fail primarily in bending and deflection. Because the beams are attached to the floor deck above, and because the joists are flush with the face of the beams, the decision was made to reinforce the existing beams rather than replace them. This will allow the current joists that do not need replacing to remain in place.

To adequately reinforce the beam, a steel plate should be bolted to the bottom of the beams. The cross section should be 8 inches wide by one half inch in depth, and the material should be grade A36 Steel, as seen in Figure 29. The plate will be secured to the beam by 7/8" diameter lag bolts spaced every 12.5" on center, as depicted in Figure 30. The steel sheets will require 15/16 inch diameter holes to allow for adequate space for the lag bolts.

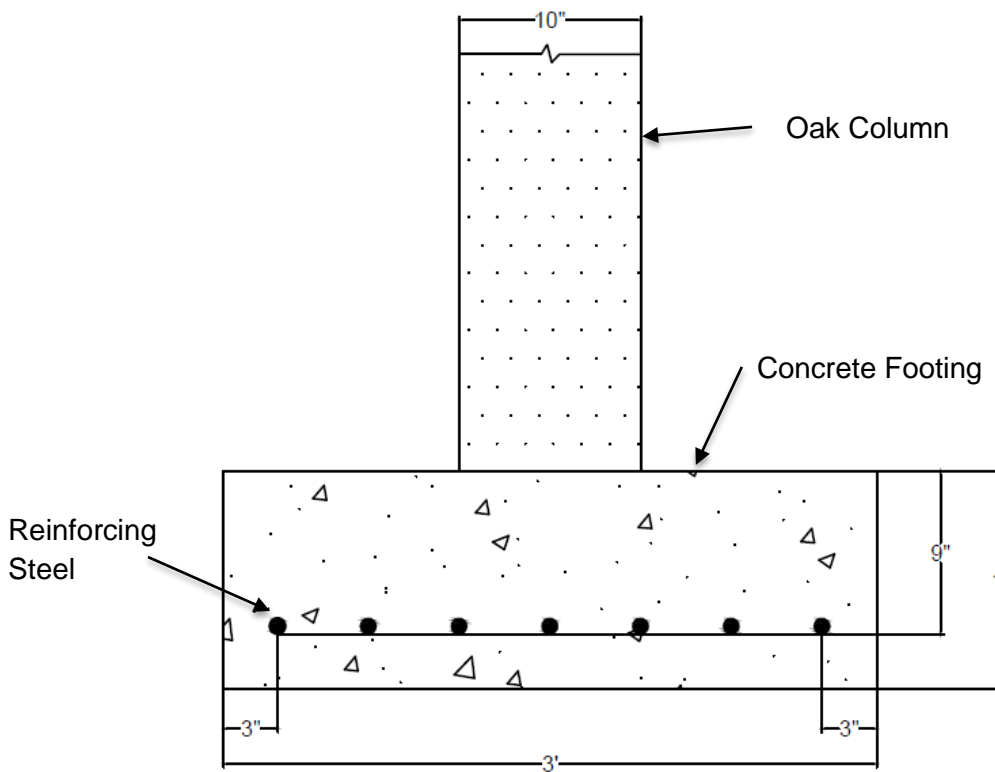
Figure 31: Column and Footing Elevation View

The four wooden support columns have sustained damage as identified in Section 4.2.3 and can no longer carry the required load. The footings for these columns are also inadequate. To solve these issues, the old columns should be removed and replaced, and new concrete footings for the columns should be poured.

The replacement columns should be square Northern Red Oak beams with a 10" x 10" cross section. These columns will have a larger cross sectional area than the existing columns, which will allow them to support the required loads. At the same time, the dimensions are similar to the existing structural members, and will allow for easy installation. It is important to note that these given dimensions are exact measurements, not nominal. When ordering a 10x10 timber beam, the actual dimensions will be less than 10" x 10". Installing a nominal 11x11 may be necessary to provide the required cross sectional area. Figure 31 depicts the base of the new column as it meets the new footing.

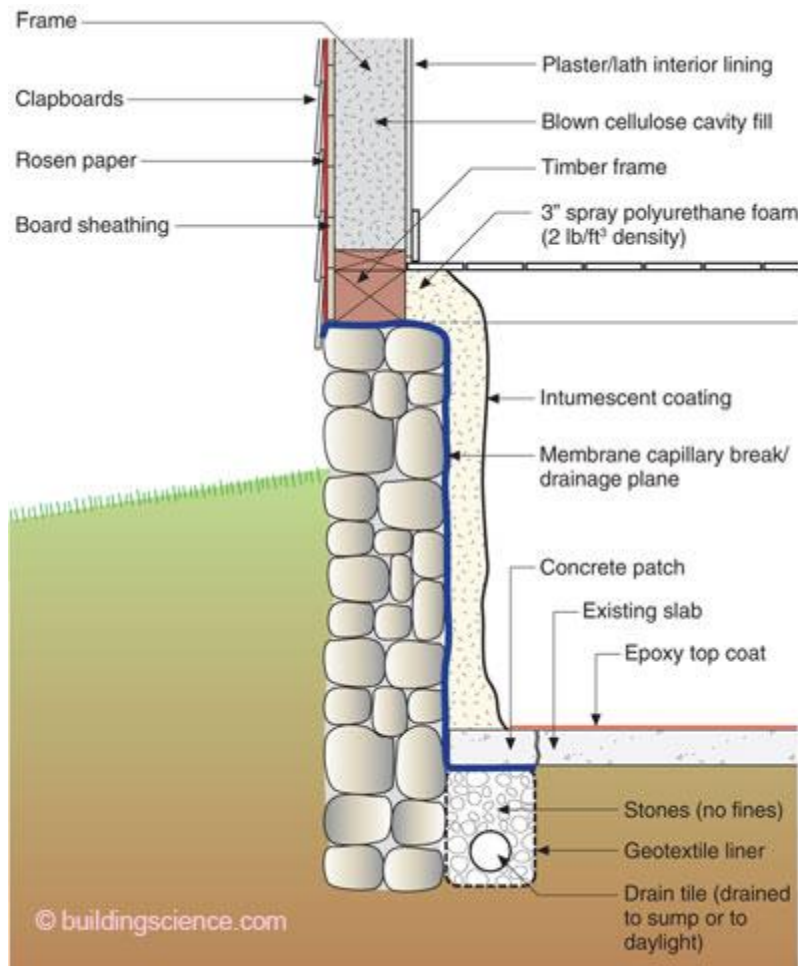
Figure 35: Interior French Drain (Lstiburek, Interior Perimeter Drain)

It was found that the significant water damage found in the basement was due to poor drainage and holes in the foundation wall. A French Drain system was proposed to seal off the holes in the foundation wall and redirect the water out of the basement. To increase the accessibility of the building, it was recommended that a landing and a handicapped rail should be installed on the staircase. This will increase the accessibility of Mechanics Hall, but there will still be accessibility issues. For example, certain measures such as handicapped restrooms are impractical due to the nature of the building. While not every aspect of accessibility can be met, a building can still be approved by the code official if an effort is made to make the building as accessible as possible. The Princeton bylaws are vague regarding the requirements for parking. Building expansions in a business district in Princeton must be approved by the town planning board.

To solve the drainage issue there are a few ways to approach the problem. The most conventional way to deal with leaking foundations is to excavate from the outside to install a perimeter drain, and install a drainage layer over waterproofing on the outside. This method tends to be expensive because of the amount of excavation that would need to be performed. Another solution that would be less expensive is to install an interior French drain. In Figure 35, shows a section view of an interior French drain system and its components.

This trench is lined with a geotextile filter fabric and contains a perforated drain and gravel. The drain pipe is either connected to a sump pump that pumps the water out or the pipe is directly extends out of the basement to daylight. Also, installing a sheet of polyethylene butyl composite liner to the interior perimeter of the foundation will create a barrier that does not let moisture into the basement. Additionally a layer of polyurethane foam (spray insulation) should be applied to the foundation walls. This foam insulation acts as a water barrier and it helps insulate the basement and also, and intumescent coating could be applied to the foam as a fire protection barrier. To maximize the amount of water kept out of the basement a slab should be placed over the existing floor. Either a sheet of polyethylene butyl composite liner should be placed under the slab or an epoxy top coating of paint applied to the surface of the slab will prevent vapor transmission into the basement.
